EXISTING CONDITIONS

PROPOSED IMPROVEMENTS

Conceptual Design

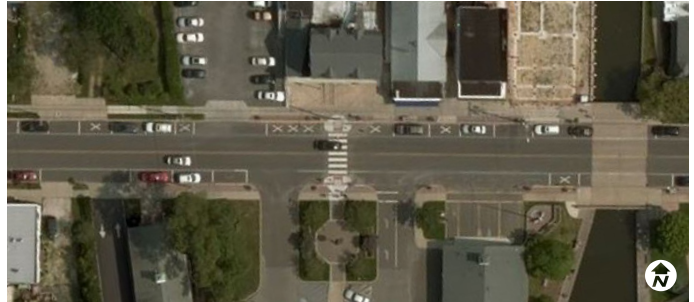
Aerial

- High pedestrian, bicyclist and motorist activity.
- Two crashes involving pedestrians have occurred at the mid-block crossing.
- Bicycle parking is limited.
- Motorists often fail to stop for pedestrians waiting to cross at the mid-block crossing. The In-Street Pedestrian Signs are mounted on the side of the road.
- The sidewalk does not continue across the driveways to the municipal lot and fire station.

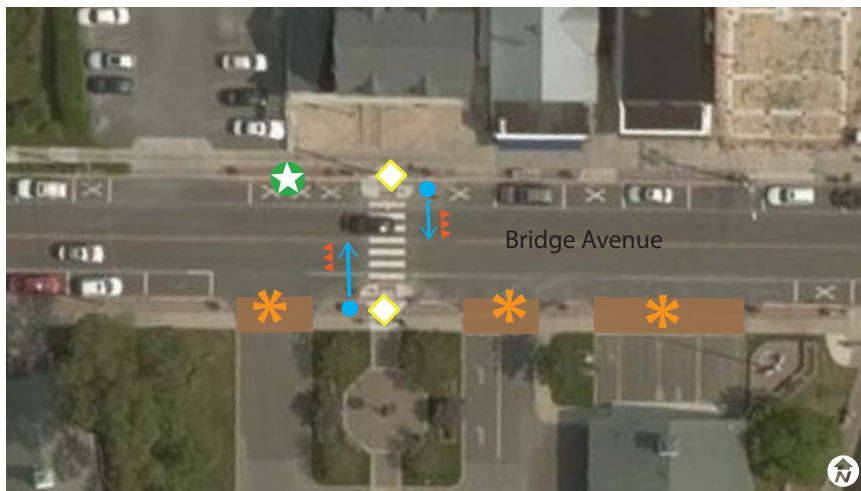
- Move the In-Street Pedestrian Crossing signs to the roadway centerline at the crosswalk location (see MUTCD Section 2B.12)
- ◆ Supplement the Pedestrian Crossing Warning signs with Rectangular Rapid Flashing Beacons (RRFB). RRFBs increase driver stopping behavior at crosswalks.

- ☆ Add a bike corral along the north side of Bridge Avenue to the west of the mid-block crossing to increase bicycle parking without losing car parking or sidewalk space

- * Continue the sidewalk across the driveway aprons to the municipal lot and fire station. Designing driveway crossings for pedestrians reduces conflicts with cars by reminding motorists that they are crossing the pedestrian realm. Consider narrowing the driveway entrance and exit to one lane.

- ▶ Add yield lines at the mid-block crosswalk to reinforce priority for pedestrians at that location and reduce conflicts between motor vehicles and pedestrians.

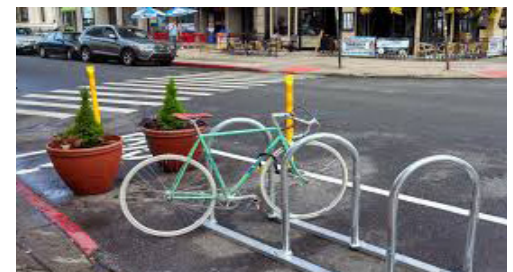
Example of a Bike Corral

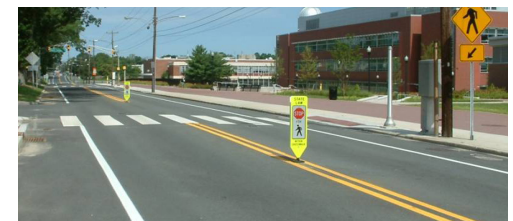
Example of an In-Street Pedestrian Crossing Sign placed on the Center Line

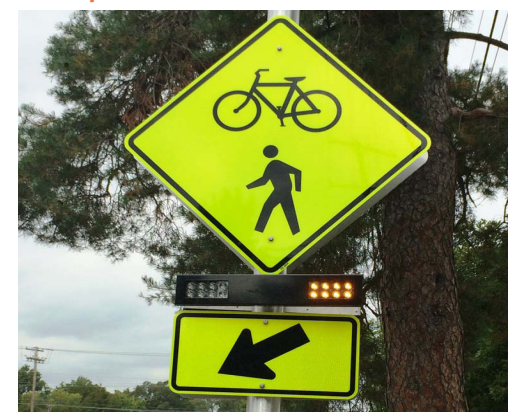
Example of RRFB
