EXISTING CONDITIONS

PROPOSED IMPROVEMENTS

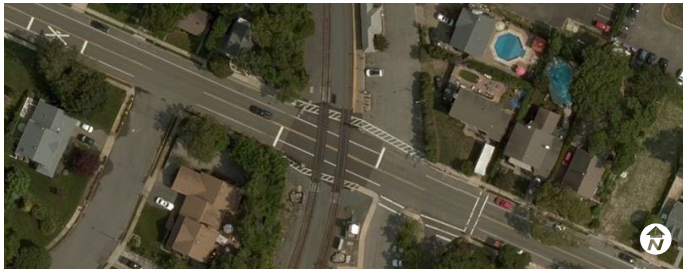
Existing Intersection

- The crosswalk across Osborne Avenue from the parking lot to the train station is not located along the pedestrian desire line.
- Bicycle parking is limited to 10 bicycles.
- Some of the curb ramps are missing detectable warning surfaces.
- Standard crosswalks are not as visible to approaching vehicles as continental or ladder style crosswalks.

- Relocate the crosswalk across Osborne Avenue to match the pedestrian desire line; restripe with high-visibility continental markings; move the stop bar back.
- Add detectable warning surfaces to existing curb ramps and to where the sidewalk crosses the railroad
- Restripe all crosswalks with continental style markings to increase the visibility of the crosswalks.
- ★ Add more bicycle parking (short- and long-term).
- ⚡ Remove/relocate striping.
